DRAINAGE PROBLEMS??? **WE CAN SOLVE THEM**

Difficult Root Cutting job Undertaken by CG Pipetec

Extensive Pipe Cleaning Carried out by CG Pipetec (UK) Ltd

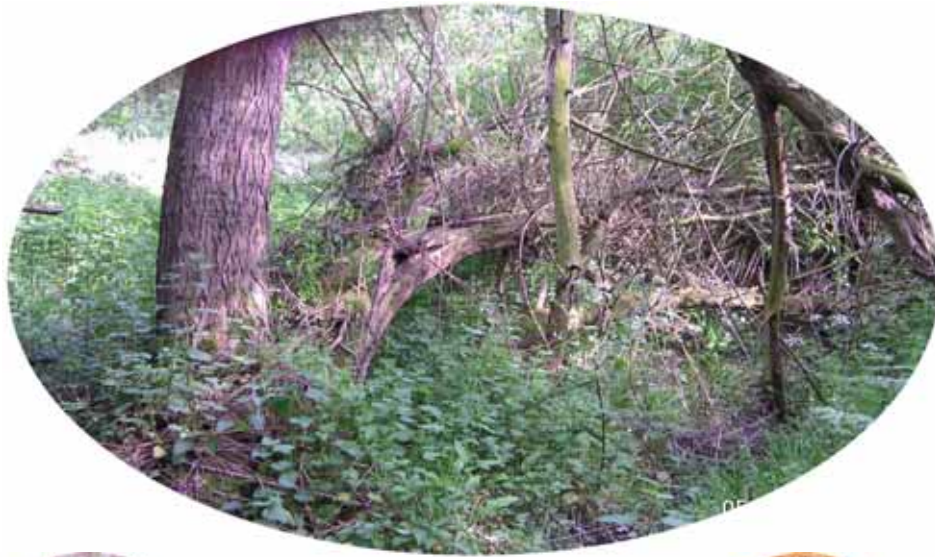
Before

after

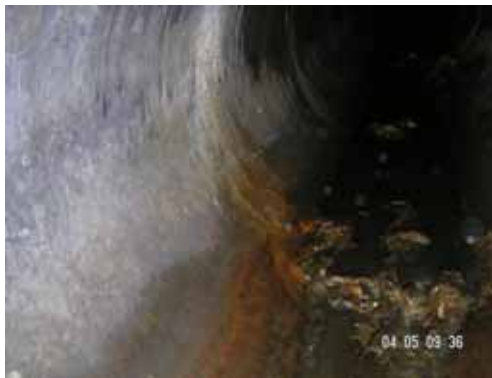
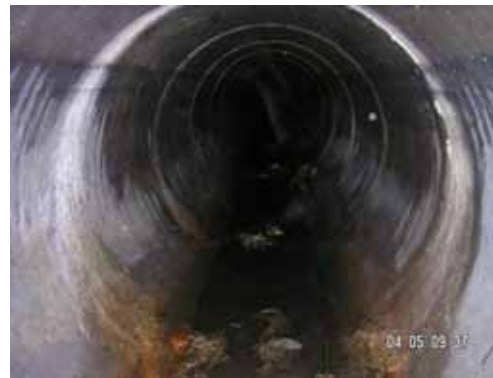
Problem:- Contaminated ground water containing Iron Oxide (Ochre) infiltrating into a 1200mm dia surface water pipe, the infiltration was seeping through the joints and causing encrustation on the pipe walls also discoloration and pollution at the outfall and to the River Don.

The pipe was used as an overflow system (CSO) from the main trunk sewer.

Solution:- The pipe was large enough to carry out man entry methods of repair. To seal the pipe joints, fibreglass and epoxy resin patches were to be used.

In accordance with all Health and Safety at Work requirements the pipe was entered and the grout was removed from the joints.

The patch material was impregnated with the resin before being wrapped around an inflatable rubber packer and lowered into the pipe. The packer was then placed over the infiltrating joints and then inflated to the correct pressure to bond the patches to the pipe walls.

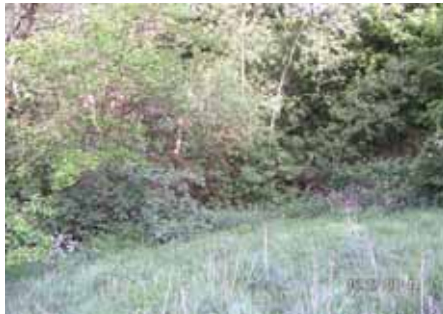
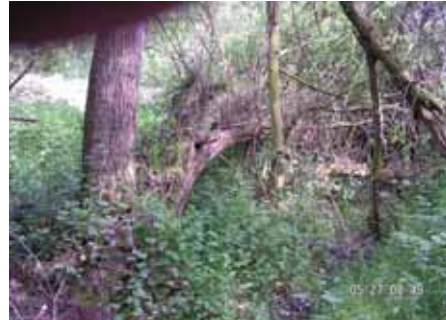
Pictures showing the type of area

Problem:- Mass Tree Roots blocking a 225mm sewer through a heavily wooded area with no access for conventional root cutting equipment or vehicles.

The most accessible manhole was located at the bottom of a steep bank in a farmers field. The manholes through the wood had been surcharging and the overspill had been contaminating the surrounding ground and a nearby watercourse.

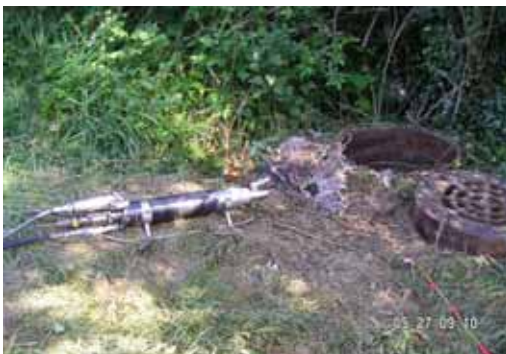
The Directional Root Cutter was placed by the manhole and attached to the winch rope ready to be placed in the pipe.

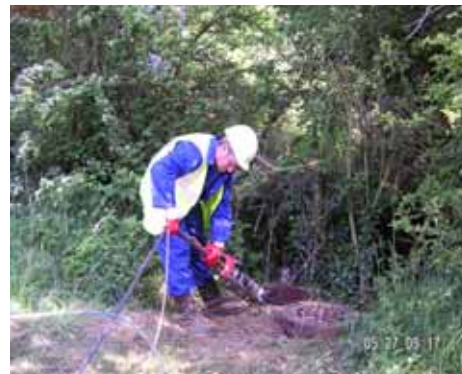
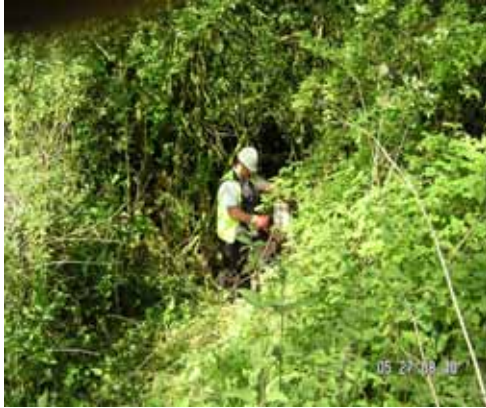
The root cutter was then placed in the pipe and pulled through the sewer to the offending roots. The cutter has a camera attached, this allows the operator to see and operate the cutter from the control panel in the back of the unit.

*The winch was located over 200m away from the unit in a very remote area of woodland, no vehicle access at all.
Our brave winch man managed to position the winch over the manhole without too much injury from the brambles and nettles*

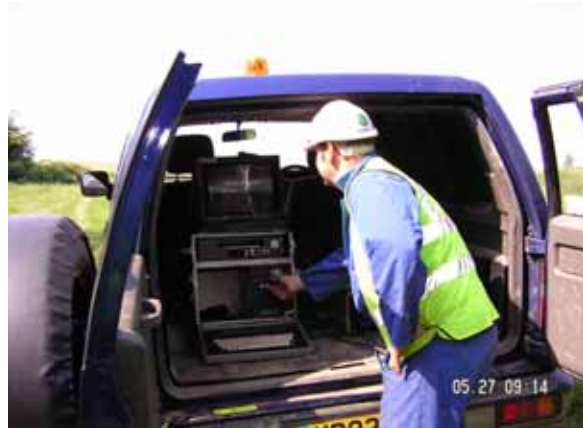
The operator was able to control and monitor the progress of the root cutting from the rear of a four x four vehicle.

Water was supplied to the cutter via a 4000psi portable jetting unit positioned by the manhole.

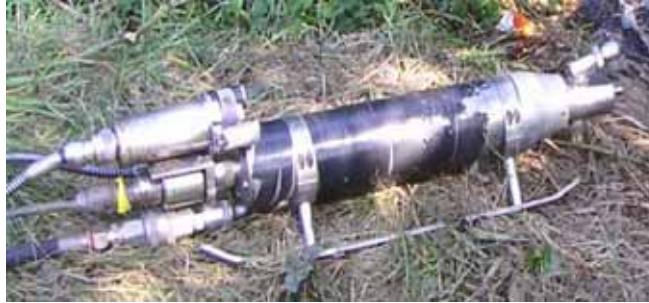
The Directional Water Cutter

- Works remotely in non man entry pipes from existing manholes
- Operates within the sewer without the need for over pumping
- Does not damage the pipe wall whilst cutting
- Video recording of completed work for clients retention
- Camera enables total control over cutting process
- Cuts hard fat, encrustation, roots, grout and intruding laterals

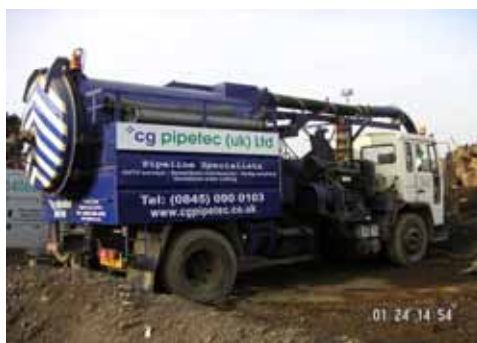
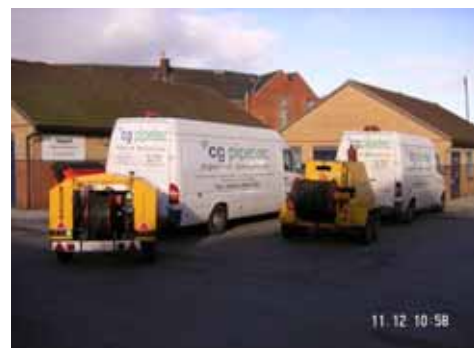
Problem:- Surface water outfall pipe not operating fully due to hard scale - grout reducing the pipe diameter by 80% to 90%. The detritus material in the pipe was a build up of steel waste and sludge that had rusted together.

Technique used:- To allow thorough cleaning of the pipe an Hydrainer pump was installed in the down stream manhole to remove the water. Man entry methods were used to break the scale into a more manageable size. The loose scale was then jetted back to the manhole using our Vector 825. With the high airflow

suction capability of this machine the loose scale was removed from the 10m deep manholes.

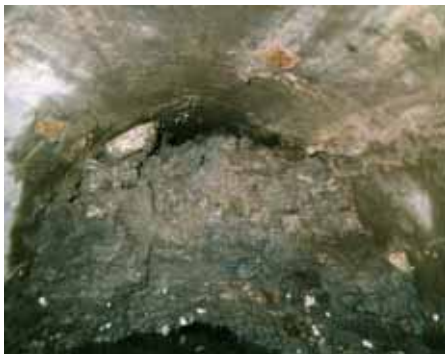
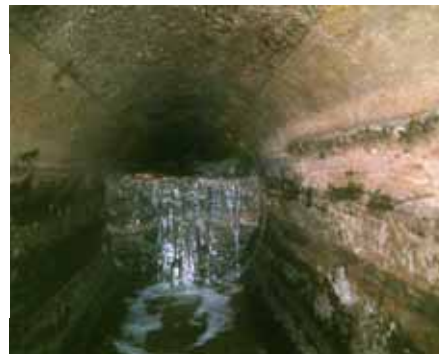
Pictures Showing The extent of the Problem

A number of manholes had been buried under tonnes of scrap metal with a few that had the covers displaced and the metal debris had also filled the manholes.

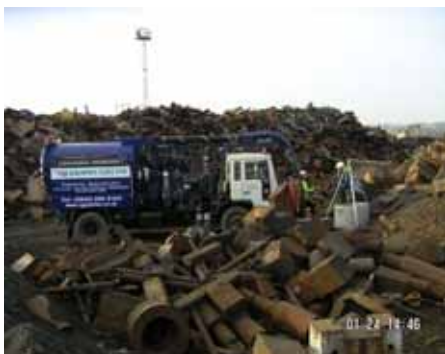
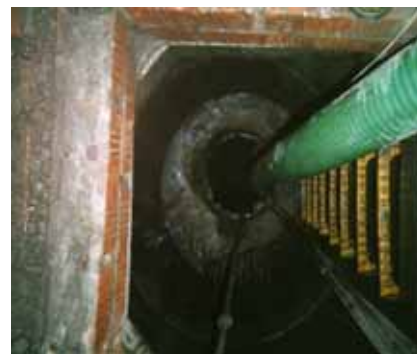
Type of Location And Manhole Showing landing

The pipe is situated under the scrap metal area at a depth of 10m. The pipe size is 0.7m in diameter with the outfall at 1m. The distance between the manholes is approximately 100m.

The chambers were then cleaned out and all the metal removed. To prevent the manholes being reburied, manhole rings were placed on top and raised above ground level.

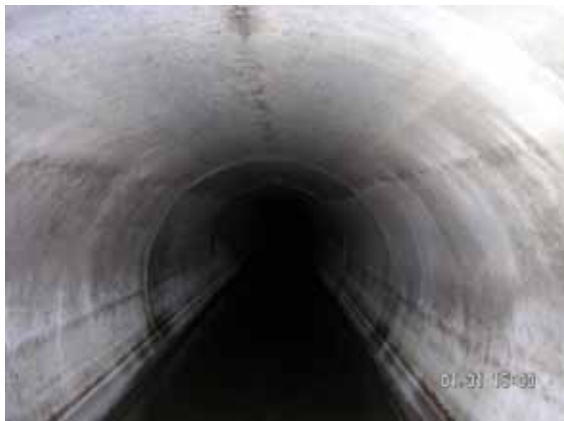
The pipe after the cleaning process had been complete

Conclusion:- After the pipe was completely clean and free of silt and debris, a CCTV survey was carried out to confirm all the scale had been removed. Now the surface water outfall is working to its full capacity it will reduce the risk of flooding and standing surface water in the area.

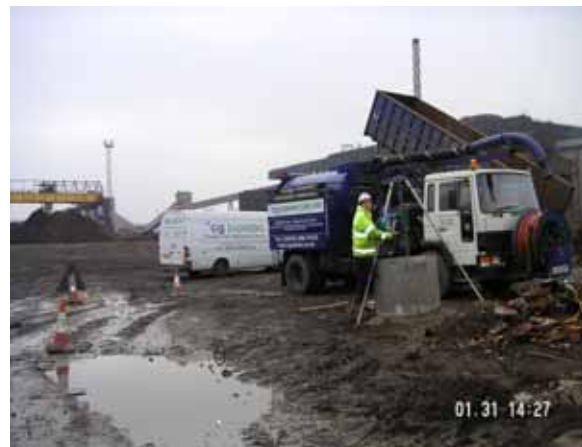
Area cleared of scrap with a new manhole ring to prevent metal being pushed back into the manhole, the heap of debris at the side of the manhole was the type of material taken out.

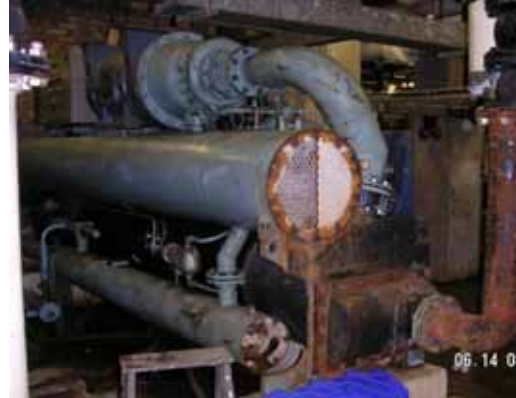
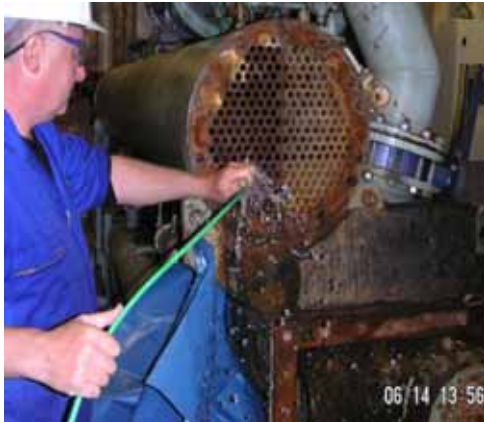
One such problem was maintenance of an Air Conditioning Condenser (chiller) this was located in the basement of a very well known shopping centre in Leeds.

The condenser was four meters long and contained 240 x14mm dia x 4m long tubes that required cleaning of lime scale build up.

Previously' the tubes had been cleaned by using a 4m long rod with a brush on the end, this was not only time consuming but not very successful.

A small high-pressure jetting hose and nozzle was adapted to fit one of our portable jetting units.

The water was pumped at 3500 psi this was sufficient to clear the blocked pipes of scale.
